ThermaCote Case Studies

CONSTRUCTION, INDUSTRIAL AND SPECIALITY

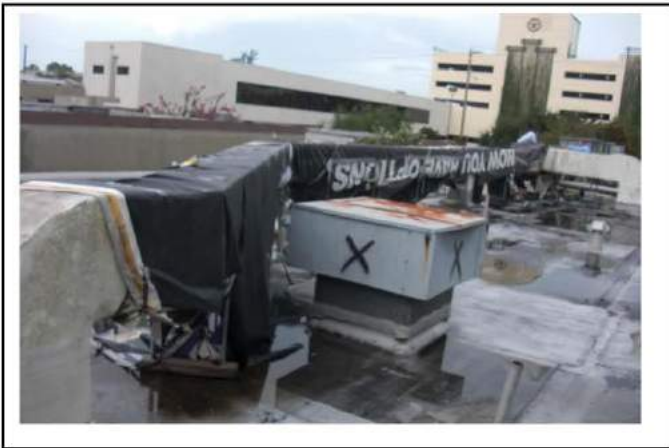
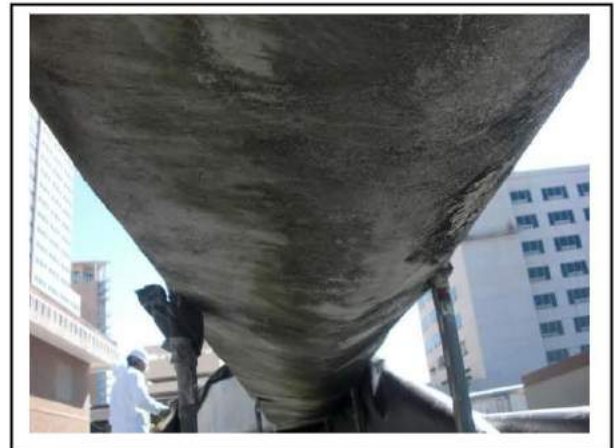
Duct prior to work

Bottom of duct has insulation that is bellied out with water

- Duct insulation was falling off as result of condensation moisture saturation
- Portions of the duct were rusting from the moisture saturation
- Several leaks were found in duct line
- AHU internally was in need of cleaning

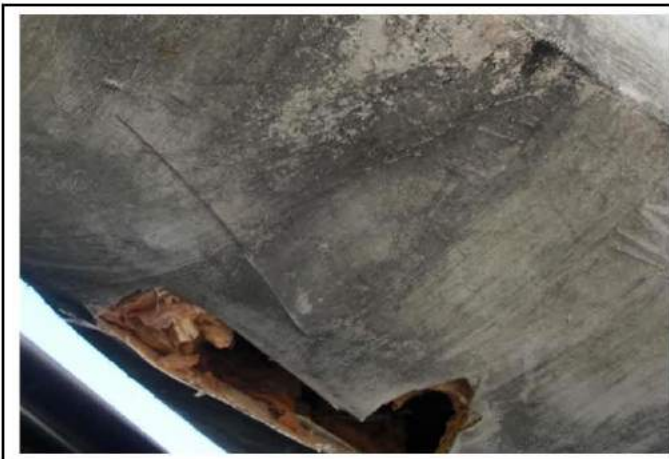
Moisture has broken through seal layer

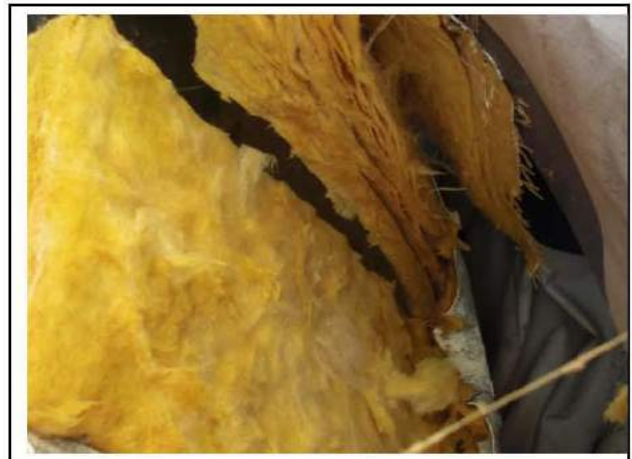
Wet insulation at unit discharge

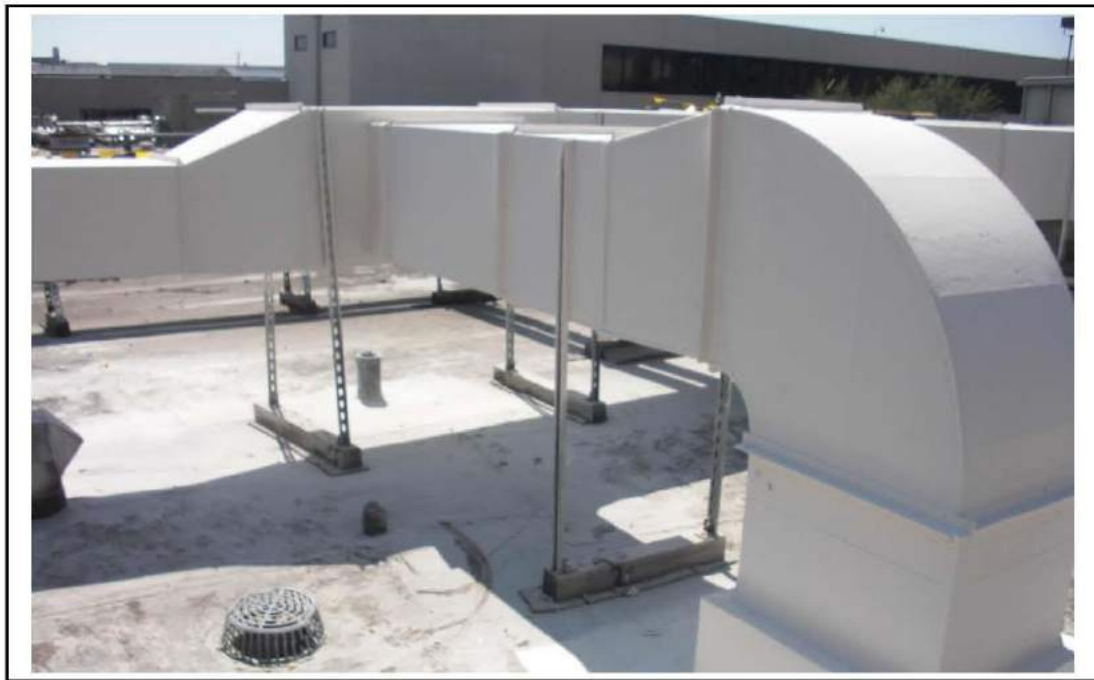
**ThermaCote® Applied**

Eliminates condensation and stops corrosion

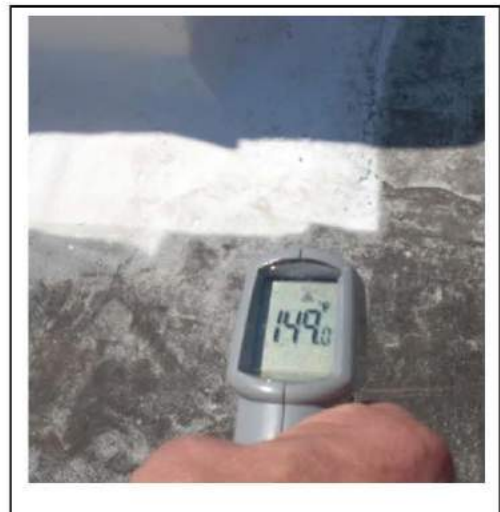
12" Apart
Coated vs.
Uncoated
Roof
Surface

57°
Difference

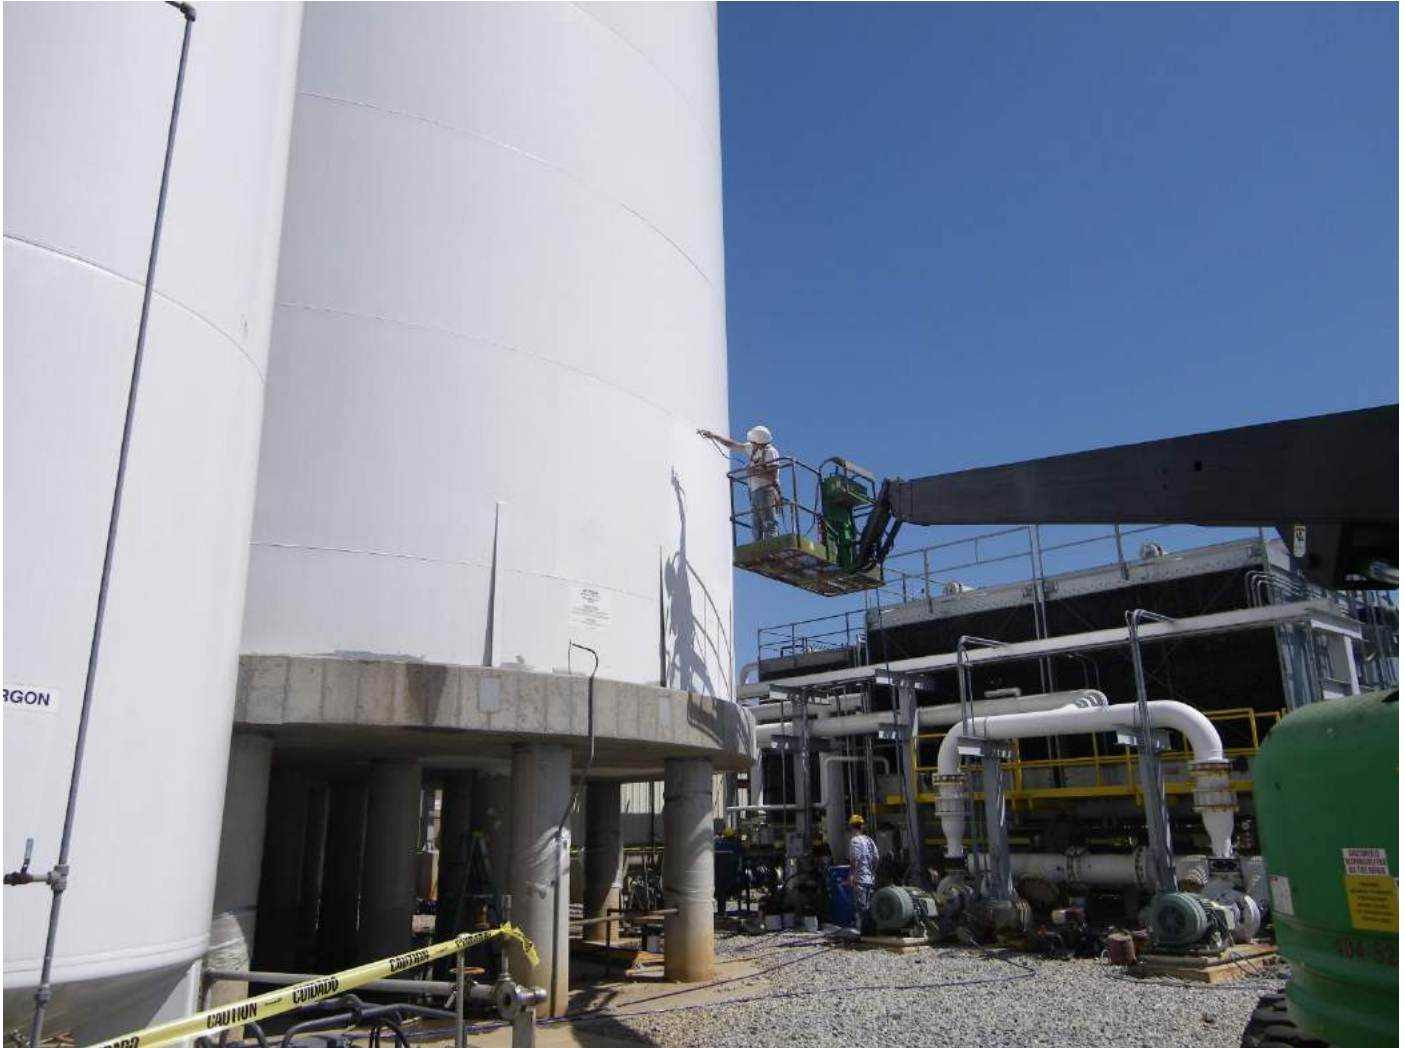
The application 'specs' are 2mm of ThermaCote® after prep. An alkyd enamel 'red metal' primer was used where blasting was required to remove corrosion.

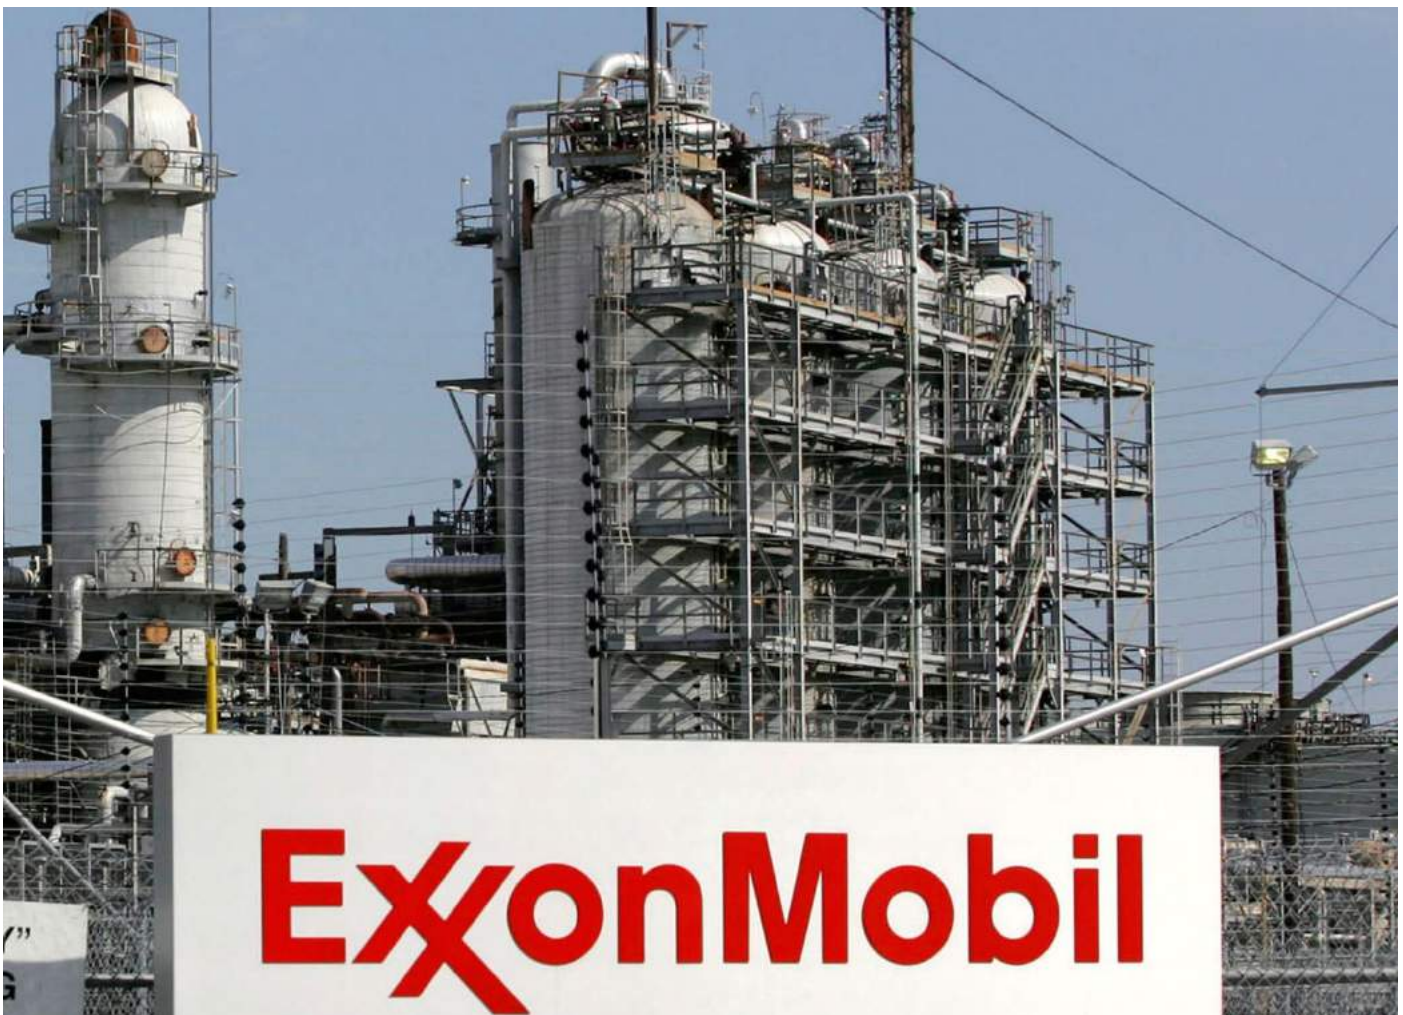
“Applied to one oil well pipe line in Florida with temperatures exceeding 265 degrees. With ThermaCote temperature was reduced by 100 degrees plus. Previously Exxon had problems keeping any type of paint coating on this well, because of extreme temperature.”

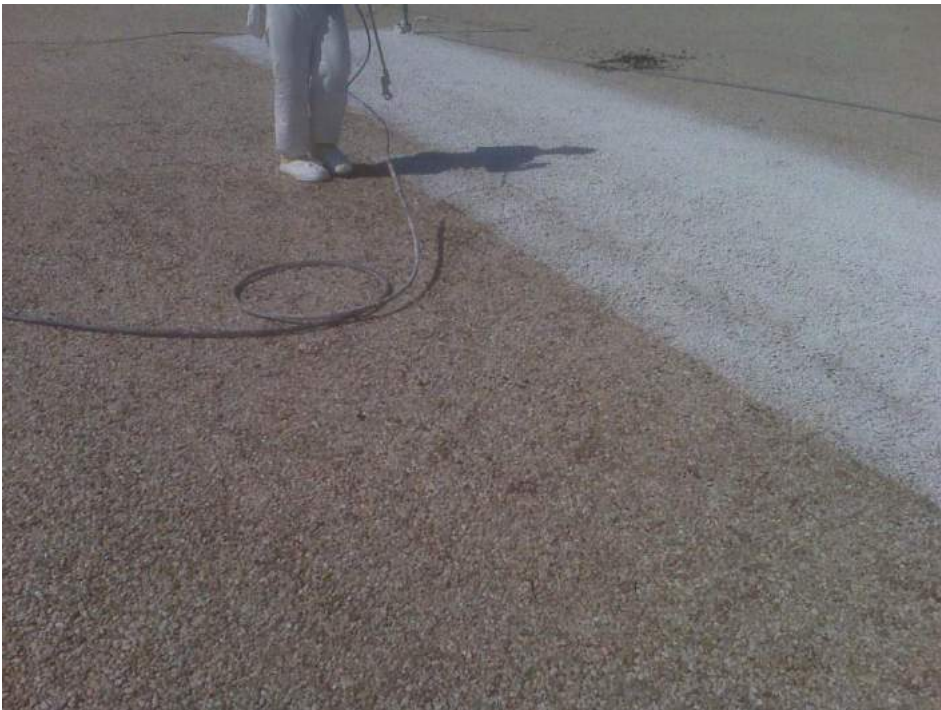
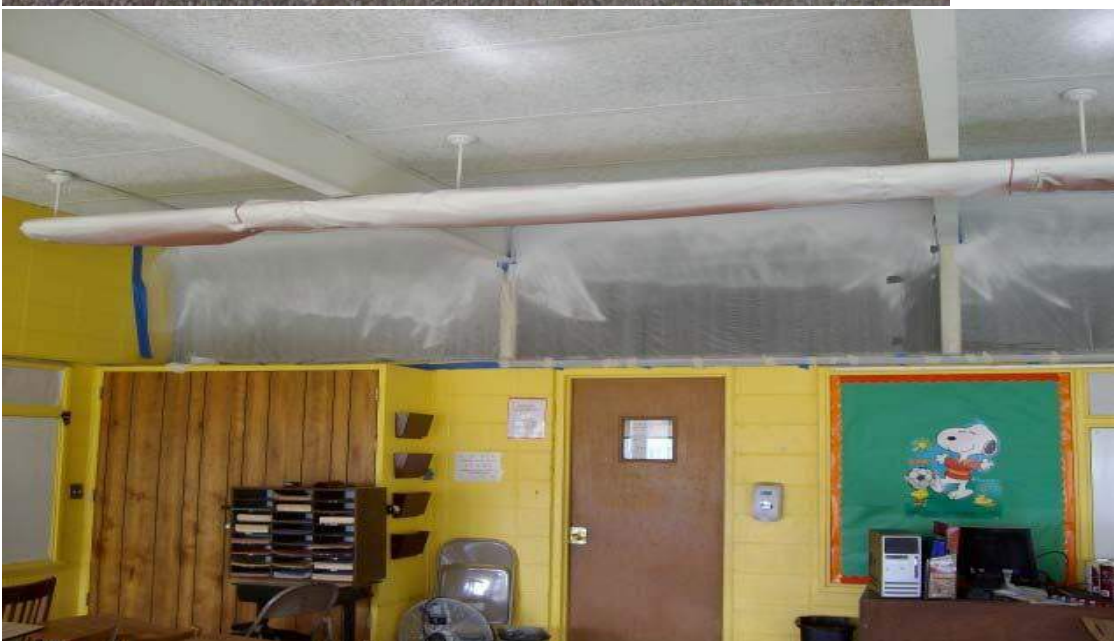
Meter readings were recorded on three separate occasions in both classrooms. Power usage in the last period of approx. 22.5 hours revealed a 40% KWH usage reduction in the coated room. Latest readings show the ThermaCote classroom at 129 KWH, and the uncoated classroom at 202 KWH. This calculates into a 36.1% reduction in electricity usage for the air conditioner in the coated room as opposed to the usage in the control room. It bears noting that this facility already had a light colored roof coating. Application of this material to dark roofs or the underside of roof decking with dark shingles would produce even more dramatic results. In addition, ThermaCote has a .83 solar reflectivity as established by the Cool Roof Rating Counsel. This high radiant reflectance can result in reduction in the number of fluorescent tubes needed to deliver an appropriate amount of light to the desktops, which could conceivably increase savings on the lighting portion of the power bill.

This calculates into a 36.1% reduction in electricity usage for the air conditioner in the coated room as opposed to the usage in the control room. It bears noting that this facility already had a light colored roof coating, (see fig. 3). Application of this material to dark roofs or the underside of roof decking with dark shingles may produce even more dramatic results. In addition, this product has a .83 solar reflectivity as established by the Cool Roof Rating Counsel. This high radiant reflectance may result in reduction in the number of fluorescent tubes needed to deliver an appropriate amount of light to the desktops. This could conceivably result in increased savings on the lighting portion of the bill.

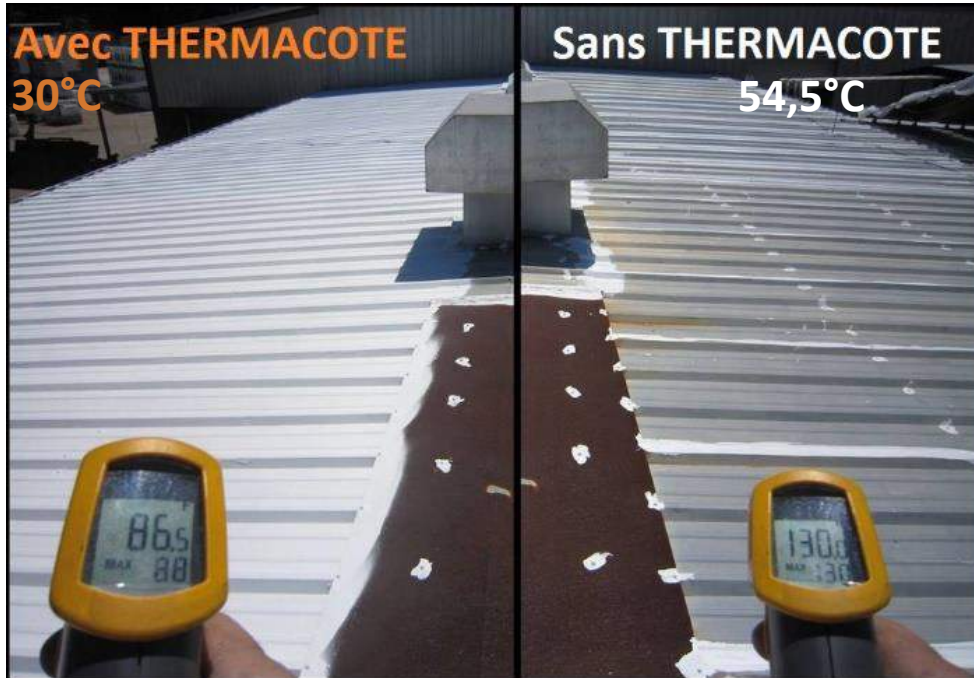
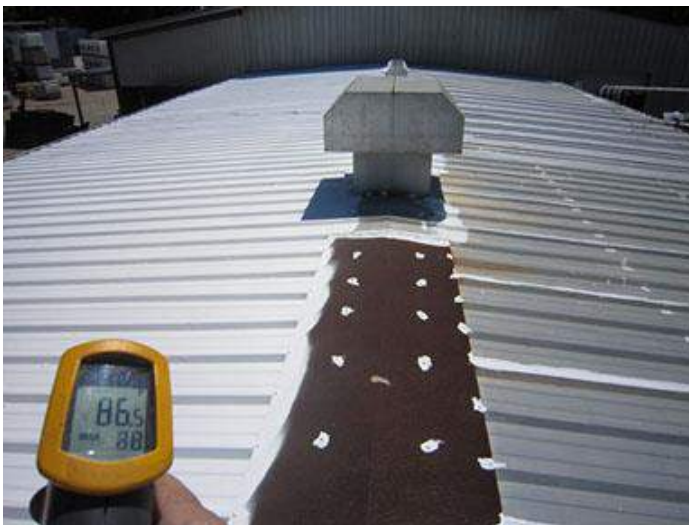
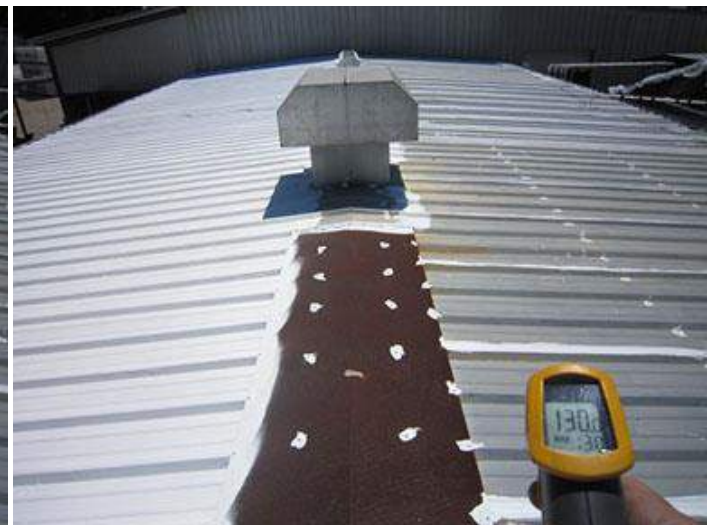
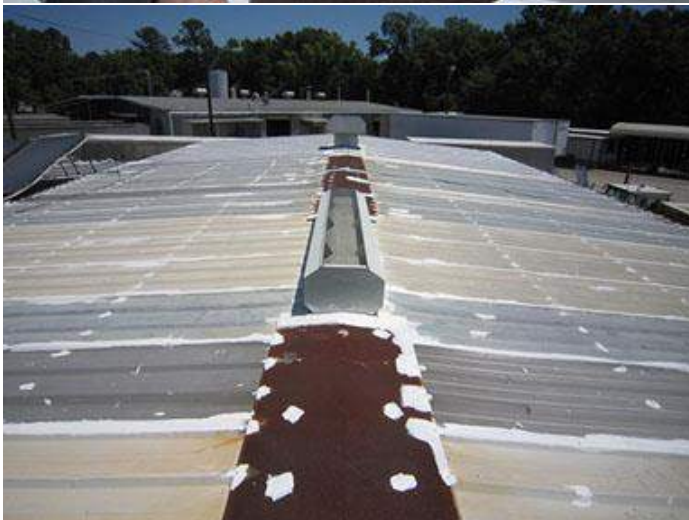
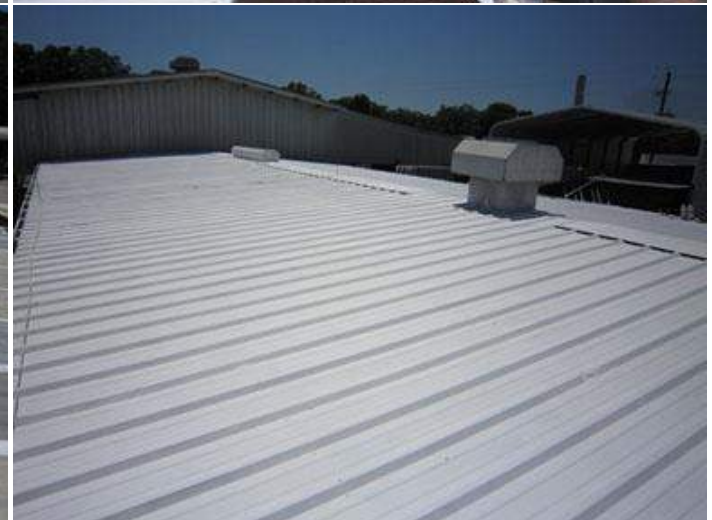
Surface temperature with ThermaCote decreased to 86°F/30°C instead of 130°F/54.44°C on normal parts.

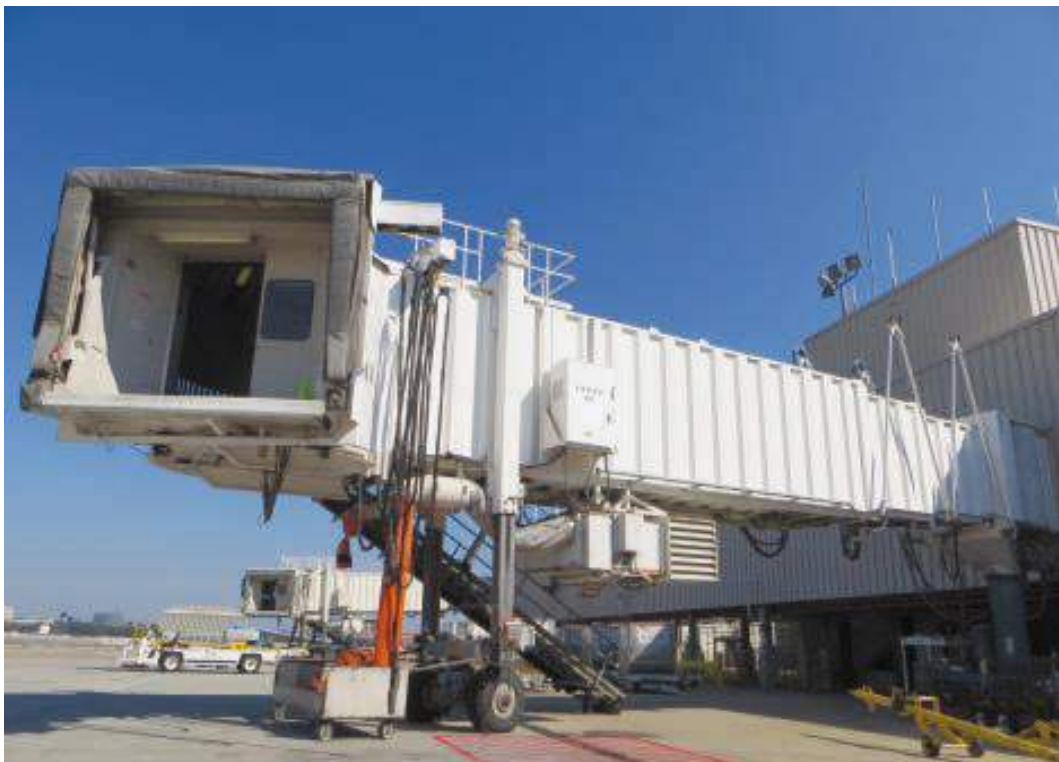
- Temperatures in the bridge coated with ThermaCote was consistently at least 2-3°F (~1.5°C) lower than in the uncoated bridge. The temperature difference appears around 10am and lasts through the night.
- The coated bridge was cooler at arrival, and continued to get cooler until departure. The coated bridge was consistently closer to human comfort levels.
- The coating appeared to reduced heat gain by an average of 69.5 btu/h (0.02 kW).
- The energy savings from the coated bridge were ~450 BTUs (.13kWh) a day. Those savings are split between the concourse and the preconditioned air handlers attached to the bridge.
- Since the product works in part by reflecting solar radiation, the savings do not necessarily apply to cold weather.

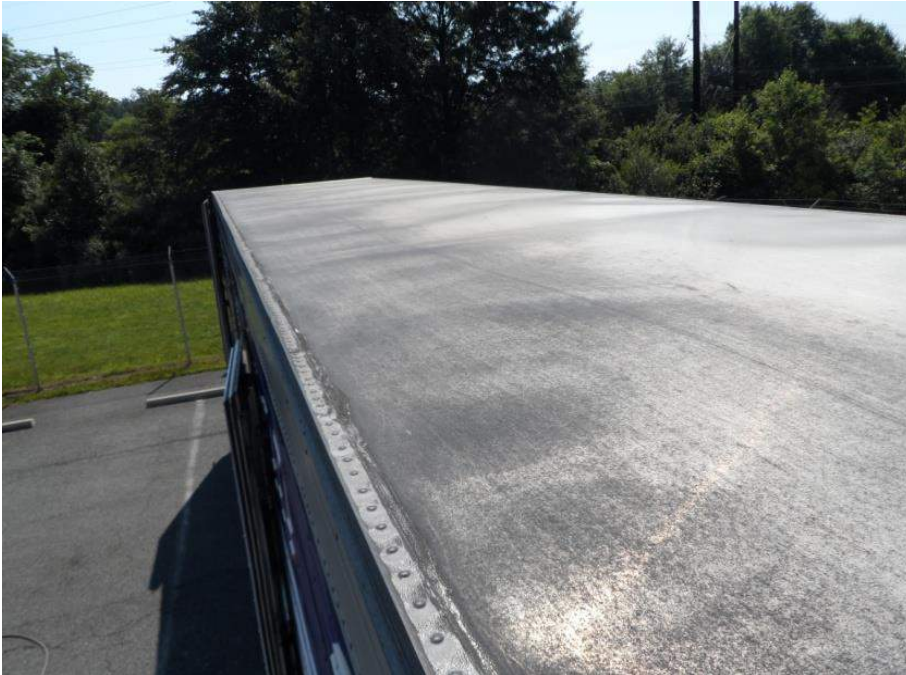
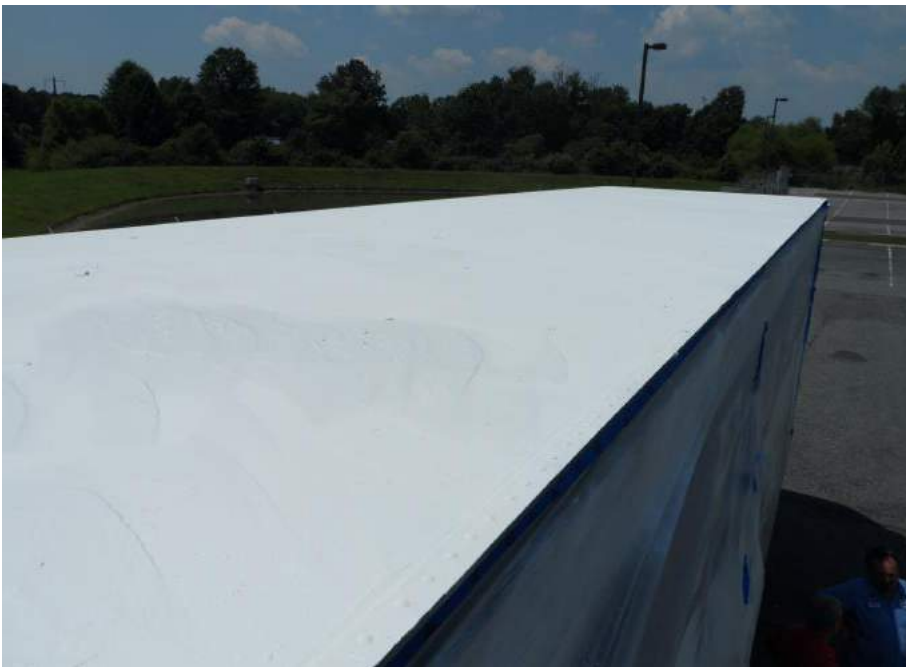
The coated trailer reached zero degrees 26% faster than the uncoated trailer.

The coated trailer used 41% less fuel for the entire test.

Test results of trailers from zero degrees for three cycles

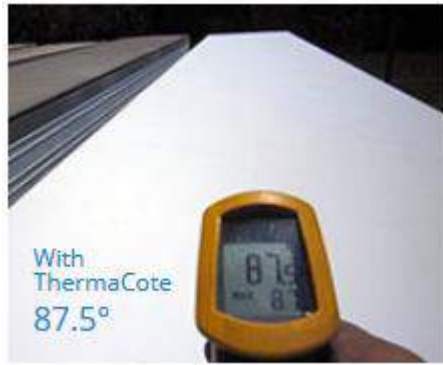
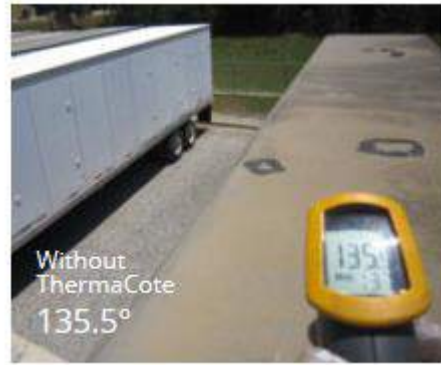
With ThermaCote the trailer roof temperature decrease to 87°F/30.56°C instead of 135°F/57.22°C on standard trailer.
